EROSION CONTROL OPTIONS & RECOMMENDATIONS

**A BRIEF REPORT TO ACCOMPANY THE
OBERNE SITE VISIT ON JUNE 3 2014**

By Cam Wilson - www.earthintegral.com

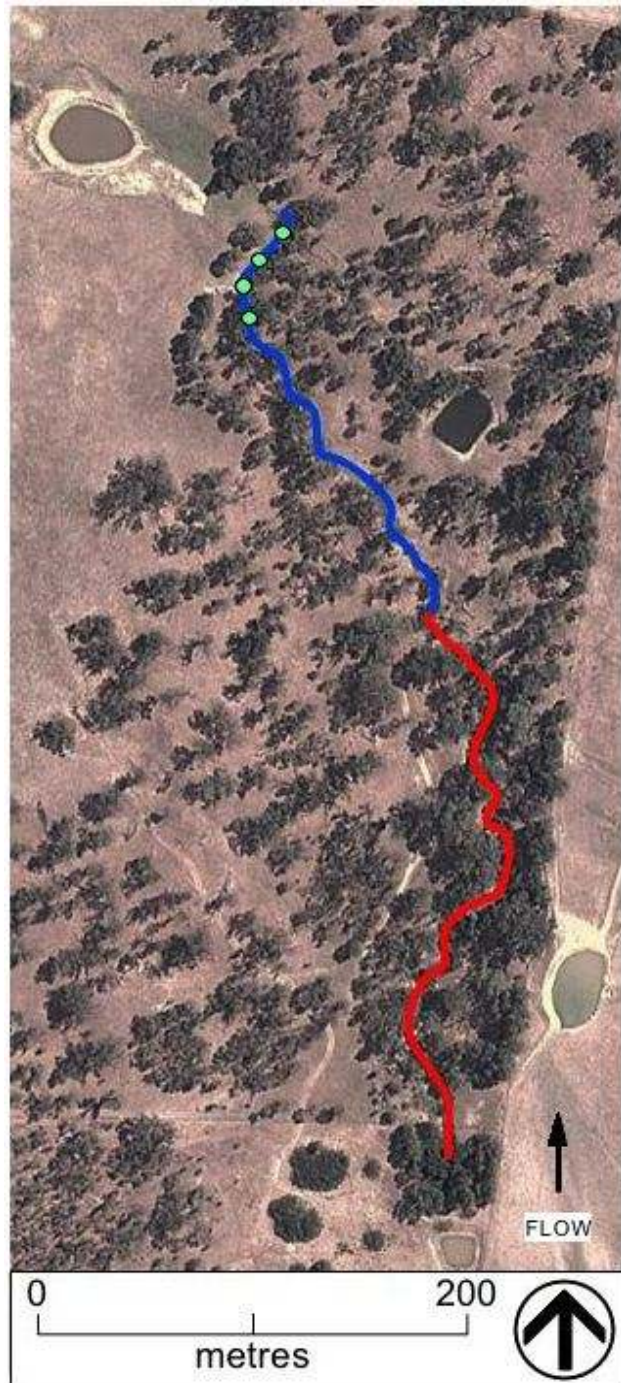
Figure 1.1: Site 1, erosion gully on Waddon

In the lower half of the gully (blue line figure 1.1) both the floor and walls have stabilised except for isolated minor erosion where tributary valleys enter (Figure 1.2).

In the upper half of the gully (red line figure 1.1) the floor has stabilised, but there is ongoing erosion of the walls caused by two separate issues, 1) self-battering of the banks and 2) undercutting and mass failure on acute bends (Figure 1.3).

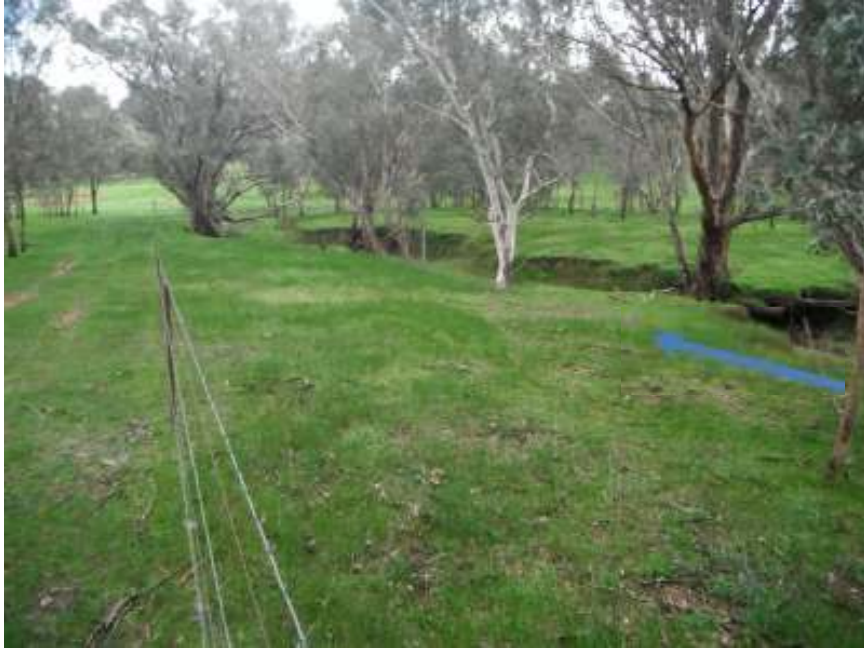
Figure 1.2: Waddon Incised gully – as a result of livestock exclusion, the floor and walls are largely stabilised in the downstream half.

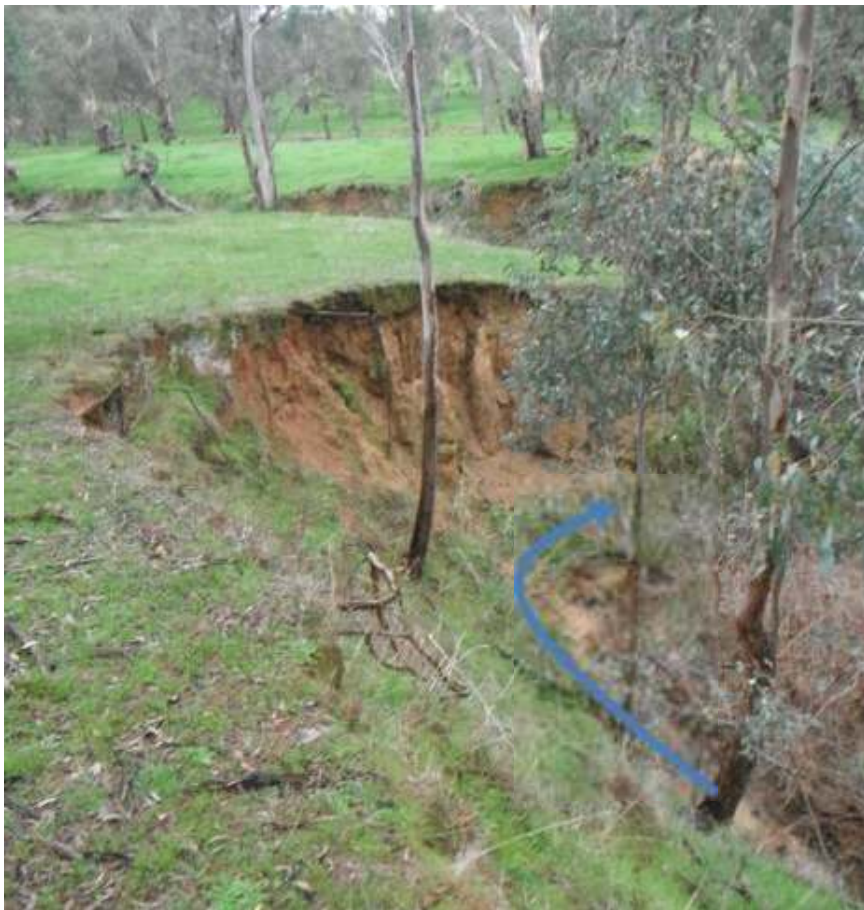
Figure 1.3: Waddon incised gully – The floor of the gully has stabilised in the upper half but undercutting on acute bends followed by mass failure is a major source of downstream sediment.

Erosion is occurring on acute bends in the upper section of the gully, with undercutting followed by slabs of sediment dropping to the gully floor and washing downstream.

Although this is a natural process following gully incision (as the channel finds a new equilibrium), this is both a major source of downstream sediment and, if this process extends in a downstream direction (figure 1.3) and breaks through into the gully further down, could initiate a new headcut as a result of the sudden change in base level.

Where severe bend erosion is occurring, some possible low cost strategies include:

1. Brush toe protection. Laying and pinning brush against the toe of the slope can minimise undercutting by deflecting flows and reducing velocity. See Appendix D for design recommendations.
2. Vegetation establishment. Tussock grasses established along the toe of the slope will play a similar role to the brush will also be binding the soil. A combination of brush (short term protection) and vegetation (long term protection) is ideal.

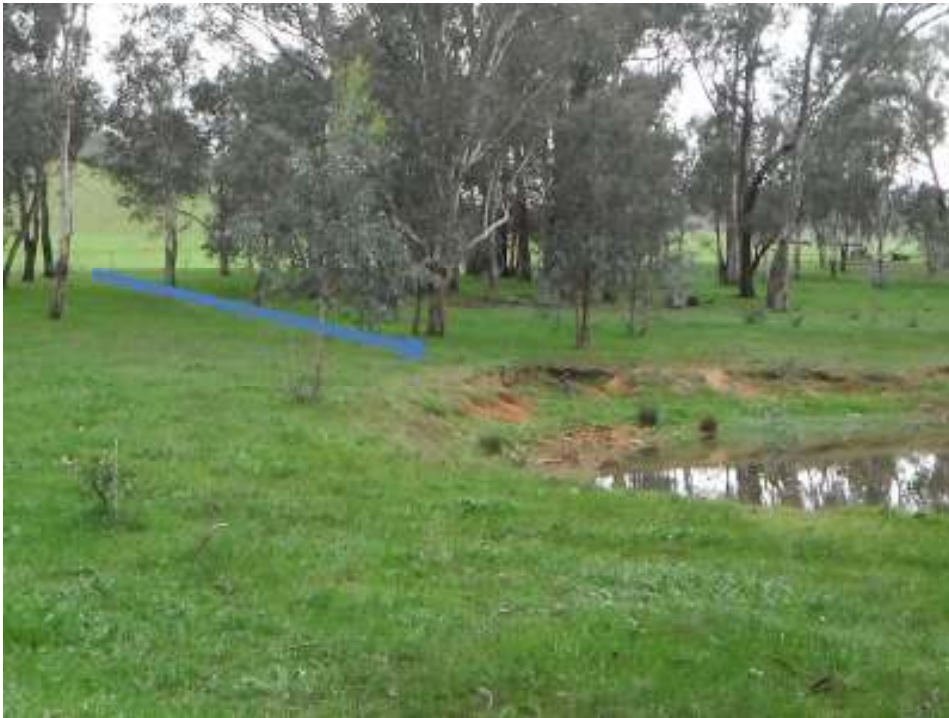
Figure 2: Site 2, minor headcut on Waddon.

Erosion feature: Minor headcut retreating at rear of dam.

Owner's concern: Upwards migration of headcut, sedimentation of dam.

1. **Grazing protection upstream of headcut.** Placement of a 'tangle' of brush and logs in a 5m x 5m area upstream of headcut helps to protect grass growth and prevent grazing to < 0.5m. This helps to reduce flow velocity, while also supporting the growth of a deeper and more vigorous root system in this area (with the associated benefits to physical and biological soil characteristics). Ensure branches are placed with the butts downhill which helps to prevent flows from altering their course and shifting the problem area.
2. **Headcut armouring.** A rock rundown (Appendix E) is a simple solution for a low energy headcut like this. It simply involves battering the cut, laying down geotextile fabric, then covering with a layer of rocks (ute-load of ~100-150mm diameter rock), keyed together from the base up.

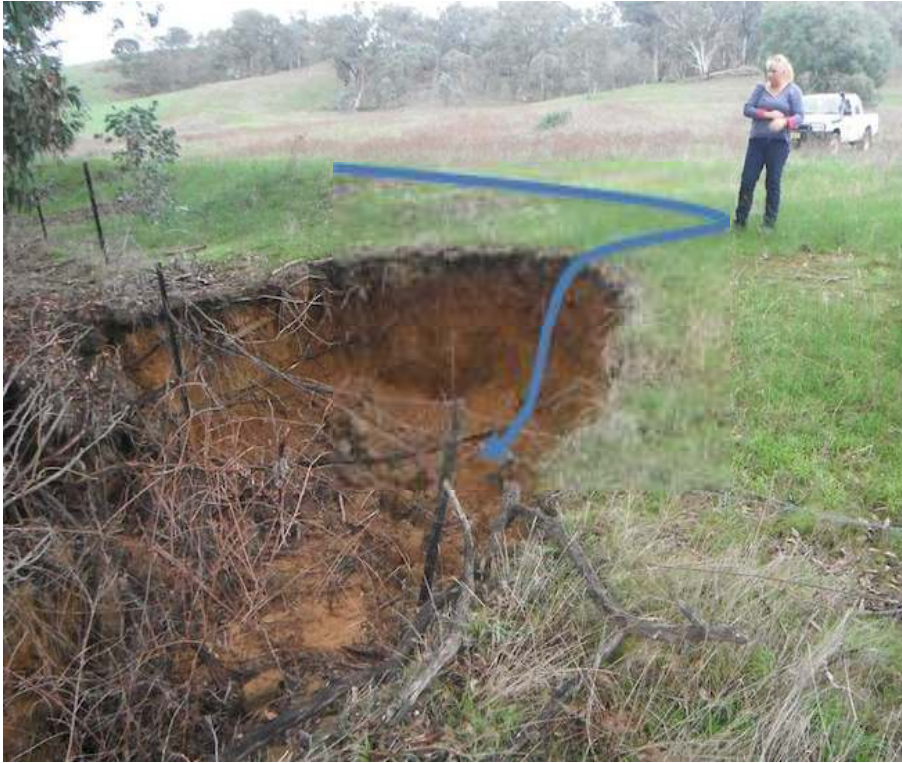
Figure 3.1: Site 3, Headcut on Zenobia.

Present gully condition: A headcut has retreated to the end of the contour outlet from a Soilcon gully diversion dam. When the dam and contour were constructed, the gully wall below the contour outlet would have been battered to disperse the flow. Since then, a nickpoint has commenced and flow is now concentrated. If left unchecked, the headcut will continue uphill along the blue line in Figure 3.1 towards the dam 30m uphill.

1. **Upstream vegetation establishment.** Whatever stabilisation option is chosen, appropriate vegetation establishment is recommended for the long term stability of the site. A dense fibrous root system is the most effective form of armouring. Although an exotic, the fibrous root system of *Populus alba* can provide an effective option when used as a tool for such purposes, as extensively demonstrated in New Zealand erosion control practices. Whichever species are chosen, armouring of the headcut is

recommended for short term stabilisation while the chosen vegetation establishes.

2. **Concrete flume:** A durable, long term engineering solution, but expensive for the landscape position ~ \$6-8,000
3. **Rock armouring:** Similar to the rock rundown solution for site 3, but because of the scale of the headcut will require a 10m³ truckload of larger diameter rock and an excavator for a couple of hours for battering the cut and spreading the rock. Gypsum application is recommended above the cut to help stabilise the soil along with the establishment of soil binding vegetation.

4. **Brush packing:** Brush packing to armour the floor and walls of the headcut are not a permanent solution (the material will eventually rot), but could buy time while vegetation establishes upstream. Some battering of the cut would be carried out during construction with the brush/log material providing reinforcement. A cut of this size would require about a day's labour for two people (or could be completed during a workshop). There is plenty of woody brush material available nearby if thinning of the regrowth timber is carried out (See Appendix F for an example).

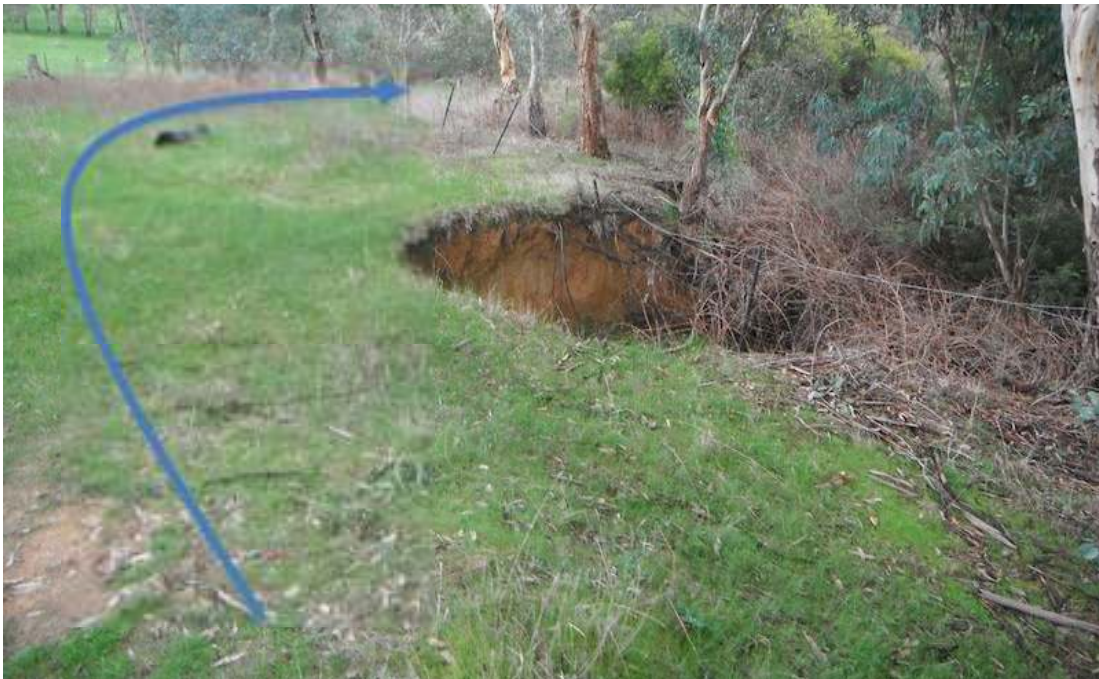
Figure 3.2: Potential flow diversion path. Shrubs seen in the background, planted on by the owners of Waddon would be threatened if another headcut commenced as a result of the new flow path.

5. **Flow diversion:** The contour diversion outlet could be extended a further 8m to starve the existing headcut (Figure 3.2). This option would take only a couple of hours with an excavator, however, in the long run it would likely create a similar issue a little further downstream, threatening an area where trees and shrubs have been planted on Waddon.

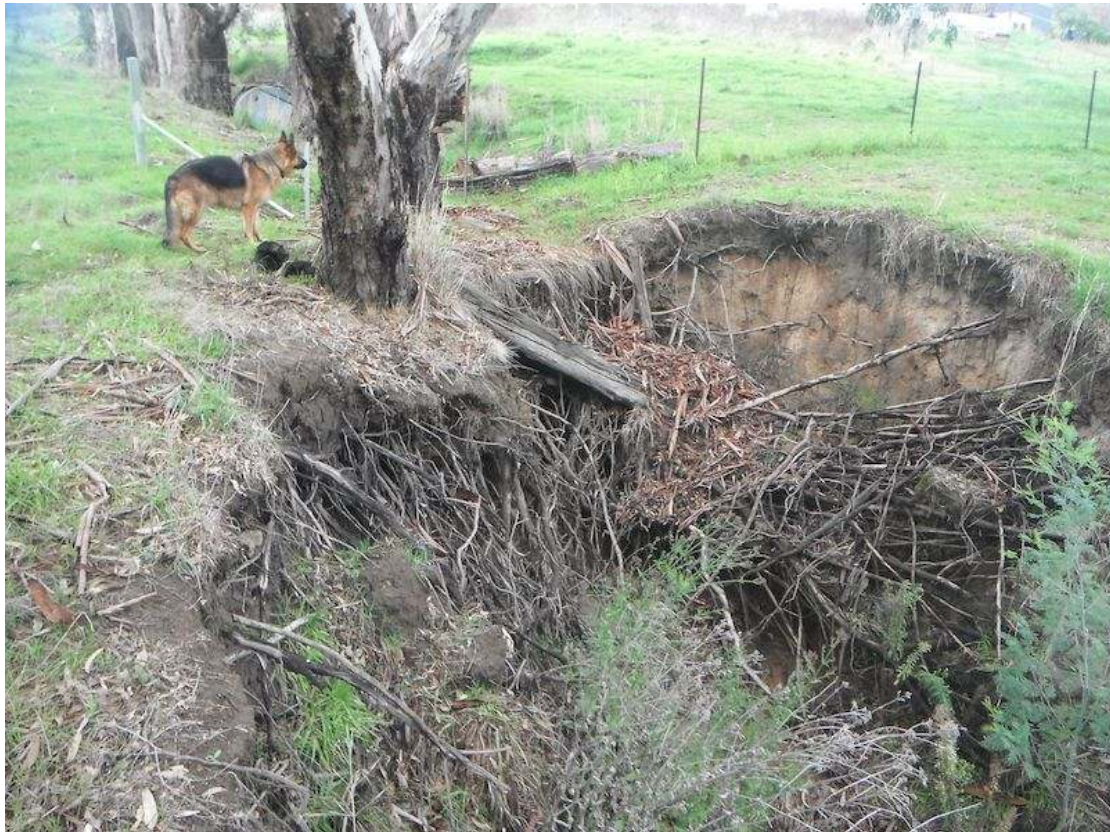
Figure 4: Site 4, Headcut on Dellhaven.

Present gully condition: The change in base level as a result of the incision of the main creek has resulted in a large dropoff which instigated the headcut during intense rainfall in 2011 when the main erosion occurred.

The root system of a large Eucalypt, one of about a dozen which have been planted along the base of the flow line (Figure 4), has played a significant role in halting the headcut migration.

Some scour has occurred back in under the tree lowest in the valley. To prevent further undercutting it is suggested that the face of the headcut be packed with either brush or old rolls of fence wire to disperse the impact of the flow as it pours over the headcut (it will need to be fed in under the vertically hanging roots seen in Figure 4).

Contact between the brush/wire and the face of the cut is important. This intercepts and prevents low flows from running down the face and dispersing the sodic B horizon. Lining the face with geotextile fabric pre-packing will also assist.

Lopping of the large branches which are angled towards the headcut/creek is recommended. This will help to take weight off the tree and reduce the chance of it toppling over. The branches would provide reinforcement and packing material at the base of the headcut.

All material should be staked and wired to prevent it floating off when the creek levels rise.
